SERVICE BULLETIN

SB-022323-B

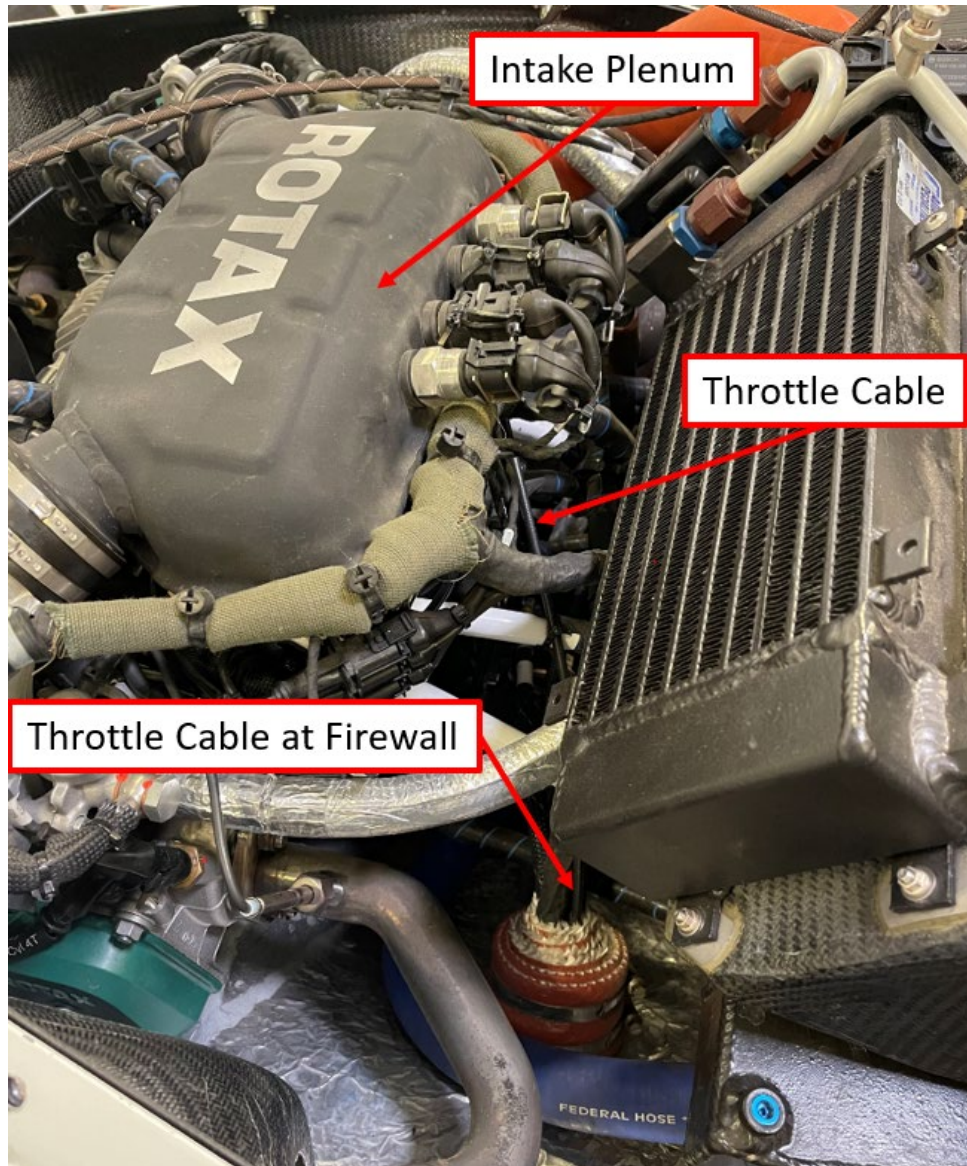
Figure 1 Throttle Cable Location

1. Remove the engine cowling.
 - a. ICON Aircraft Maintenance Manual: Remove Engine Cowlings ([100497](#)).
2. Locate the throttle cable at the lower intake plenum mount.
 - a. See Figures 1 and 2.

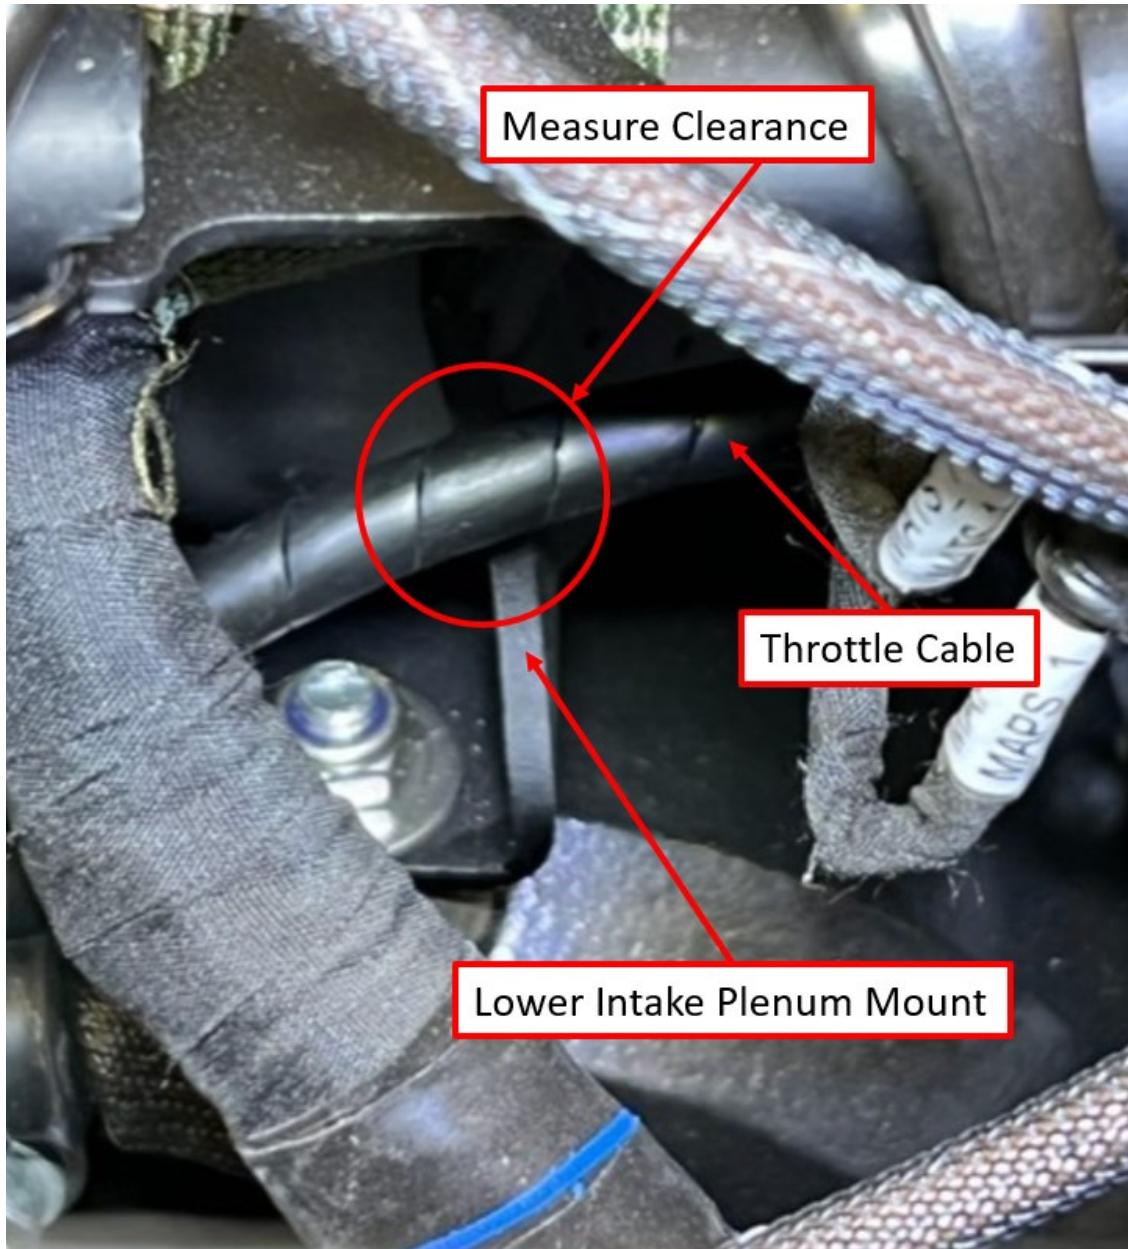
Figure 3 Clearance at the Intake Plenum Mount

3. Measure the clearance between the throttle cable and the lower intake plenum mount.
 - a. There should be a minimum of $\frac{1}{4}$ " clearance.
 - b. See Figure 3.
4. Verify that there are two cable ties securing the throttle cable to the engine mount.
 - a. See Figure 5.
5. If there is less than $\frac{1}{4}$ " clearance between the throttle cable and lower intake plenum mount *or* only **one** cable tie is securing the throttle cable to the engine mount, then proceed to the "Repair" section of this service bulletin.
6. If there is a $\frac{1}{4}$ " or greater clearance between the throttle cable and lower intake plenum mount *and* **two** cable ties securing the throttle cable to the engine mount, then proceed to the "Logbook Entry" section of this service bulletin.

2. Verify F4 Tape is installed on the engine mount where the throttle cable is intended to be secured.
 - a. Install F4 tape if there is none where the throttle cable is intended to be secured.
3. Re-locate the throttle cable, along the engine mount, until a $\frac{1}{4}$ " or greater clearance is achieved between the throttle cable and lower intake plenum mount.
4. Ensure that the throttle cable remains over the F4 tape on the engine mount.

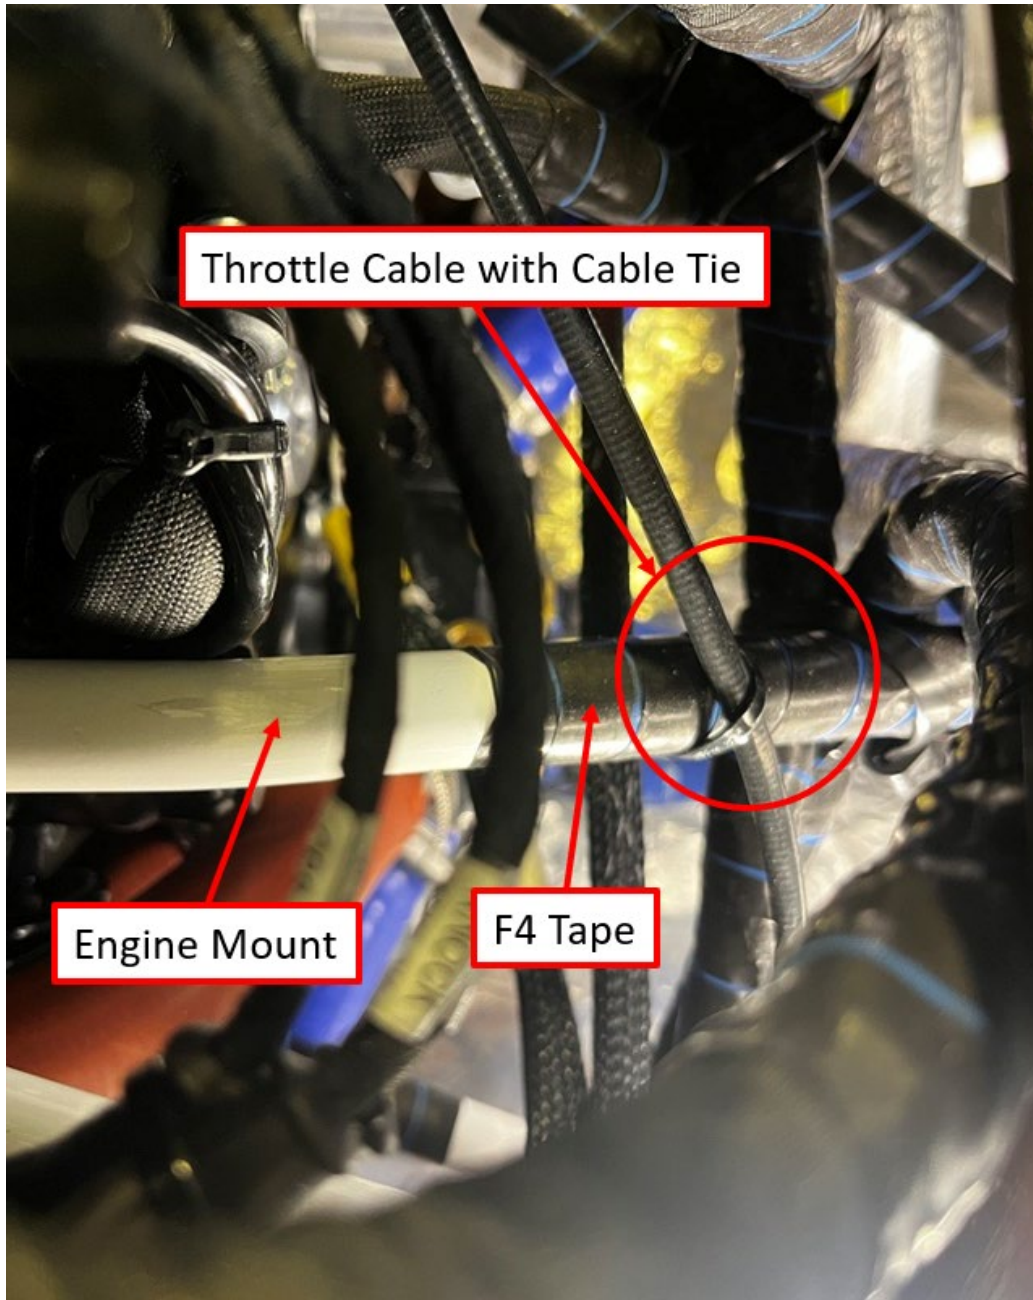
Figure 4 One Throttle Cable Tie at Engine Mount

NOTE: There must be **two** cable ties securing the throttle cable to the engine mount. If there is a $\frac{1}{4}$ " or greater clearance and only one cable tie securing the throttle cable to the engine mount, then another cable tie must be installed as shown in Figure 5.

1. Remove the cable tie to the throttle cable and engine mount.
 - a. See Figure 4.
