# SERVICE BULLETIN

## SB-041323-A

**ID NUMBER & REVISION:** SB-041323-A  
**SUBJECT:** ELT Antenna Corrosion  
**RELEASE DATE:** 8 June 2023  
**EFFECTIVE DATE:** 8 June 2023  
**SUPERSEDES NOTICE:** N/A  
**AIRCRAFT AFFECTED:** **MAKE & MODEL:** ICON A5  
**SERIAL NUMBERS:** 00001 – 00185  
**REQUIRED ACTION:** Perform a one-time inspection of the ELT antenna to identify any corrosion and remove and replace the ELT assembly as necessary.  
**TIME OF COMPLIANCE:** One time inspection, at the next service interval.  
**REVISION HISTORY:** A Initial Release

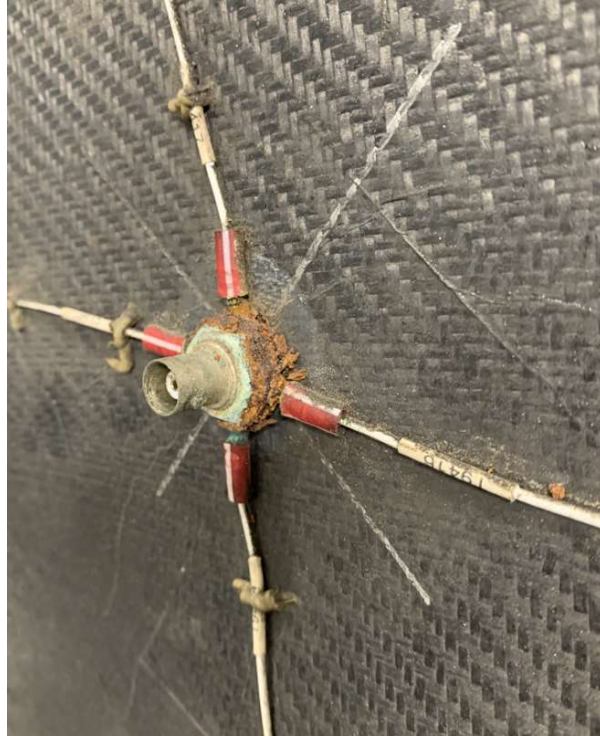
1. Remove the top engine cowling.
  - a. ICON Aircraft Maintenance Manual: Remove Engine Cowlings (100497).
2. Inspect the antenna connectors and grounding wires underneath the top cowling (non-painted side) for evidence of corrosion.
  - a. See Figure 1 for an example of corrosion.
  - b. If there is corrosion, proceed to “Repair – Corrosion” section of this Service Bulletin
  - c. If there is no corrosion, proceed to “Logbook Entry”.
3. Inspect the steel wire located on the ACK ELT Whip Antenna, on top of the cowling (painted side) for evidence of corrosion.
  - a. See Figure 2 for inspection location.
  - b. If there is corrosion, proceed to “Repair – Corrosion” section of this Service Bulletin
  - c. If there is no corrosion, proceed to “Logbook Entry”.

*Figure 1 Evidence of Corrosion Underneath the Cowl*

**NOTE:** If the base of the ACK ELT Whip Antenna and/or the steel wire at the top of the ACK ELT Whip Antenna is corroded, then the entire antenna assembly will have to be removed and replaced.

1. If not already performed, remove the top engine cowling.
  - a. ICON Aircraft Maintenance Manual: Remove Engine Cowlings ([100497](#)).
2. Carefully remove the nut, star washer, and four ground rings of the ELT antenna, underneath the cowling.
  - a. Discard the nut and star washer, a new nut and star washer is supplied with the new ACK ELT Whip Antenna.
3. Carefully remove the ELT Antenna.
4. Carefully clean the four ELT grounding rings and wires with isopropyl alcohol.
5. If the grounding rings and/or wires need to be replaced, dis-bond and remove adhesive in accordance with the following instructions:

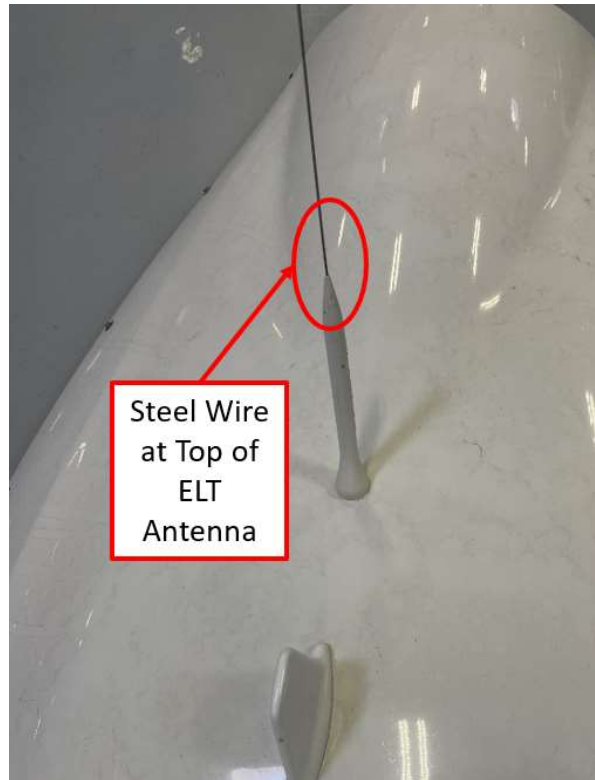
*Figure 2 Steel Wire at Top of ELT Antenna*

19. Ensure that the ACK ELT Whip Antenna is straight pointing AFT after installation.
  - a. See Figures 5, 6, and 7.
20. Using isopropyl alcohol, thoroughly and carefully clean the top of the ACK ELT Whip Antenna:
  - a. See Figure 2.
21. Install the top engine cowling.
  - a. ICON Aircraft Maintenance Manual: Install Engine Cowlings ([100335](#)).
22. Proceed to “Logbook Entry”.
