SERVICE BULLETIN

SB-062322-B

ID NUMBER & REVISION: SB-062322-B
SUBJECT: Air Rudder Hinge Pin
RELEASE DATE: 20 April 2023
EFFECTIVE DATE: 20 April 2023
SUPERSEDES NOTICE: SB-062322-A
AIRCRAFT AFFECTED: **MAKE & MODEL:** A5
SERIAL NUMBERS: 00001 – 00137, 00139, 00141 – 00146, 00148 – 00149, 00151, 00153

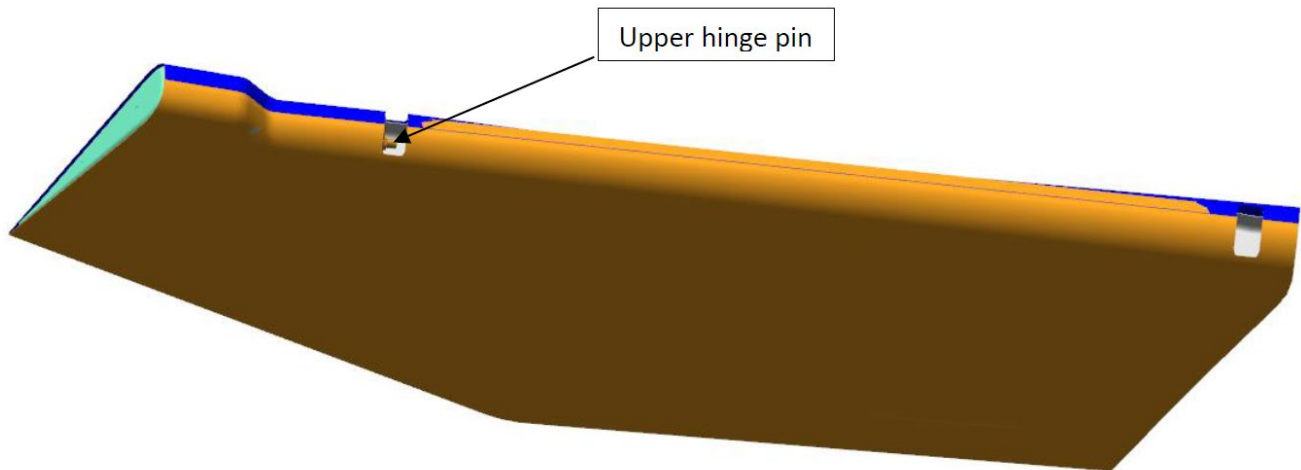
Figure 1 Upper Air Rudder Hinge Pin

ICON Aircraft has identified that the air rudder upper hinge pin may have been under torque during manufacturing. Torque values below 48.7 in-lbs may cause loss of rudder effectivity during normal flight operations. However, loss of the air rudder control surface during flight is unlikely due to the locking nature of the hinge pin and nut plate. In addition, the presence of the lower hinge pin and control cable attachment should prevent separation under normal flight conditions.

2. Inspect the upper air rudder hinge pin for a torque setting between 48.7 in-lbs and 58.7 in-lbs by starting with torque wrench at 48.7 in-lbs and verifying the air rudder hinge pin does not rotate.
 - a. If the torque is between 48.7 in-lbs and 58.7 in-lbs, proceed with steps 2.b and 2.c.
 - b. Install the Air Rudder in accordance with the latest release of the Aircraft Maintenance Manual, ICA000833.
 - c. Create a logbook entry in the airframe logbook (see “Logbook Entry B” below).
3. If the torque is not between 48.7 in-lbs and 58.7 in-lbs, proceed with the following corrective actions.

1. Set torque to 58 in-lbs and torque the air rudder hinge pin. Apply torque stripe, so it will be visible when the air rudder is reinstalled.
2. Install Air Rudder in accordance with the latest release of the Aircraft Maintenance Manual, ICA000833.
3. Create a logbook entry in the airframe logbook (see “Logbook Entry A” below).
