SERVICE BULLETIN

SB-072816 REV A

DATE ISSUED: 7/28/2016
DATE EFFECTIVE: 7/28/2016
SUPERSEDES NOTICE: None
SUBJECT: Oil and fuel line installation inspection
AIRCRAFT AFFECTED: **MODEL:** ICON A5
S/N: 00001, 00003 - 00010
REQUIRED ACTION: Inspect flexible engine compartment fuel and oil lines and replace if damaged.
TIME OF COMPLIANCE: Immediately

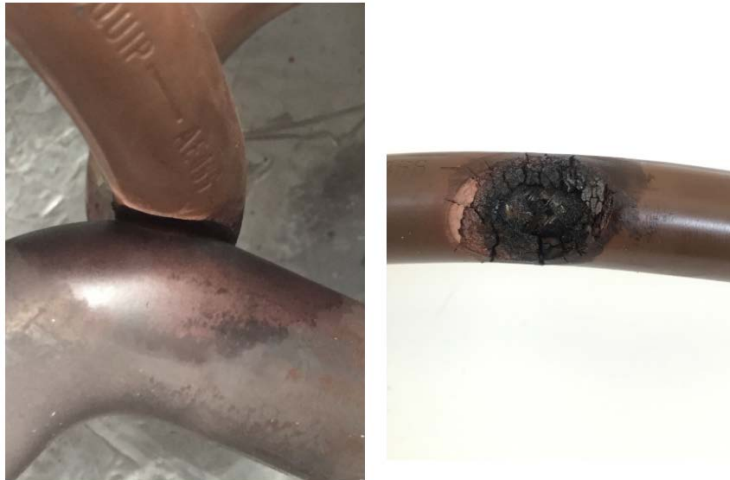
It was discovered during post flight check that ASN00004 had engine oil on the vertical stabilizer, horizontal stabilizer, propeller, spinner, and general engine compartment area. Upon inspection, the oil supply line from the oil cooler to the engine oil pump was pressed against the forward left exhaust header and had a hole burned into it.

Oil was discover leaking from the burnt hole.

1. Drain engine oil per ICON A5 maintenance manual.
2. Remove line with min clearance violation.
3. Inspect entire length of line for signs of damage or burn marks.
4. If damage is found discard line and replace with new.
5. If no damage is found, re-install line and ensure clearance from line to exhaust system components is equal to or greater than .5".
6. Perform oil change per ICON A5 maintenance manual.
7. Re-install engine cowling

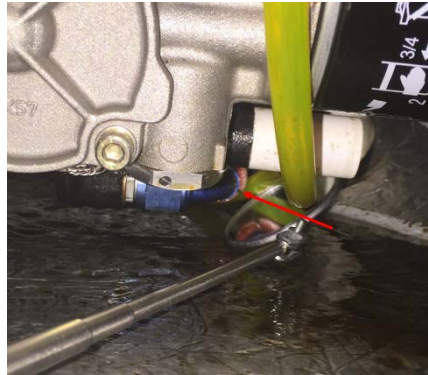
Inspection also revealed a crack in the oil return line fitting sheath on the engine side.

The line was removed from the aircraft and pressure checked. No leakage was present. Although there have been no customer safety or performance notifications from a leaking oil or fuel line, to date, ICON Aircraft is implementing a solution to prevent possible leakage as a result of damage to the lines. This Service Bulletin is to provide instructions on how to inspect line installation and determine if line replacement is needed.

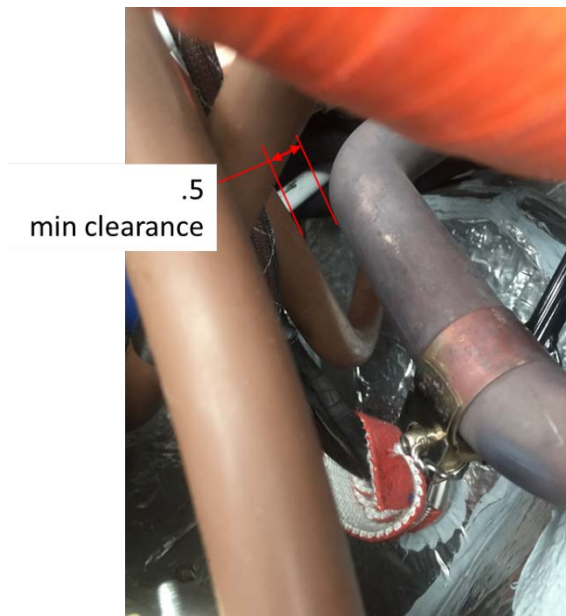
2. Inspect all flexible oil and fuel lines from parts list for clearance and wear contact. These lines are located in the engine compartment. All lines listed in parts list must have .5" minimum clearance from any exhaust system components (headers and mufflers) in installed state.
