SERVICE BULLETIN

SB-080321-A

“The corrective action of Service Bulletin SB-080321-A (Inspection of Repair of Parachute System Retention Bracket) has been complied with (ref. FAA Exemption 10829B)”.

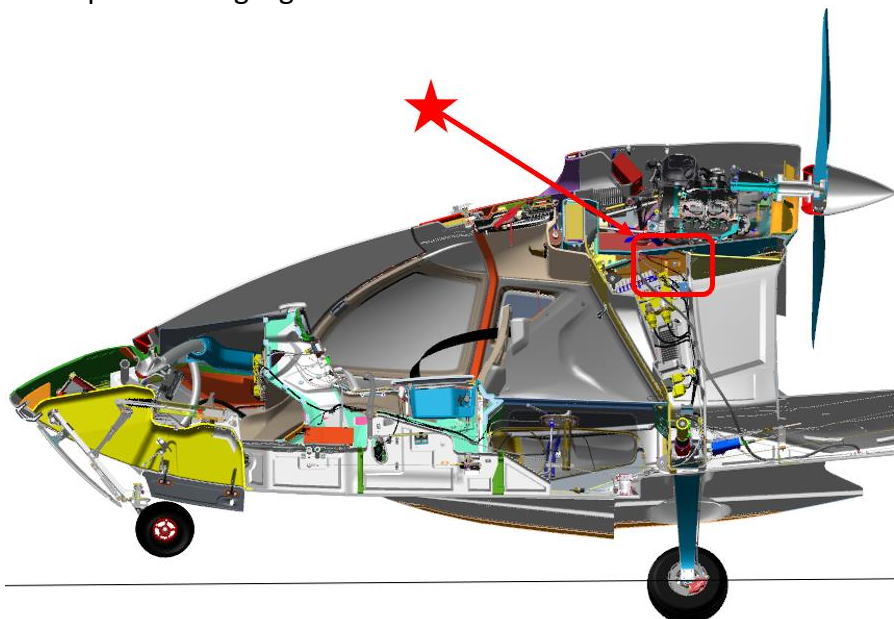
Figure 1: Aircraft section. Right half shown.

- 1) In accordance with the current release of the Aircraft Maintenance Manual, ICA00833, remove components necessary to gain access to the compartment aft of the baggage compartment between the forward and aft bulkheads. Components to be removed are as follows:
 - a. LH/RH Seatbacks (remove in accordance with AMM Section 3.6.2.13)
 - b. Aft Bulkhead Baggage Panel (remove in accordance with AMM Section 3.6.1)
- 2) A cross section of the aircraft is provided below in Figure 1. The cross section is from front to back and divides the aircraft into right and left halves with the right half shown. The area of the repair to be inspected is highlighted in red.

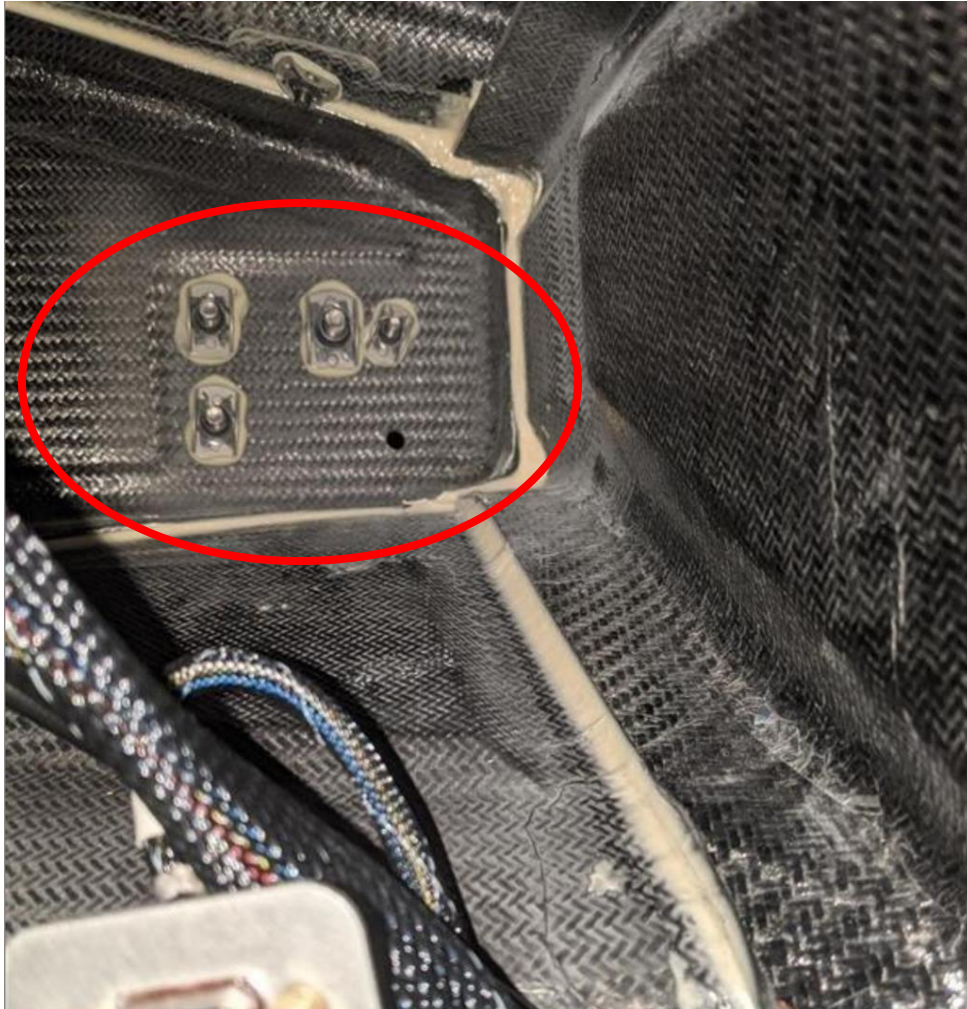
- 3) Figure 2 shows the right-side parachute harness bracket attachment points for the Parachute System that need to be inspected/photographed.

Figure 2: Attachment Point/Inspection Area

- 4) Take detailed photos of attachment point area for submission to ICON.
- 5) If the attachment point area resembles Figure 3 below, i.e., it appears that two separate secondary carbon fiber repair plates have been bonded in place and there is evidence of adhesive squeeze-out or squeeze-out cleanup around the perimeters of the repair plates, then additional photos of the attachment area that indicate the sizes of the repairs must be taken and submitted to ICON. Figure 4 shows a satisfactory method to show the sizes of the repair plates.

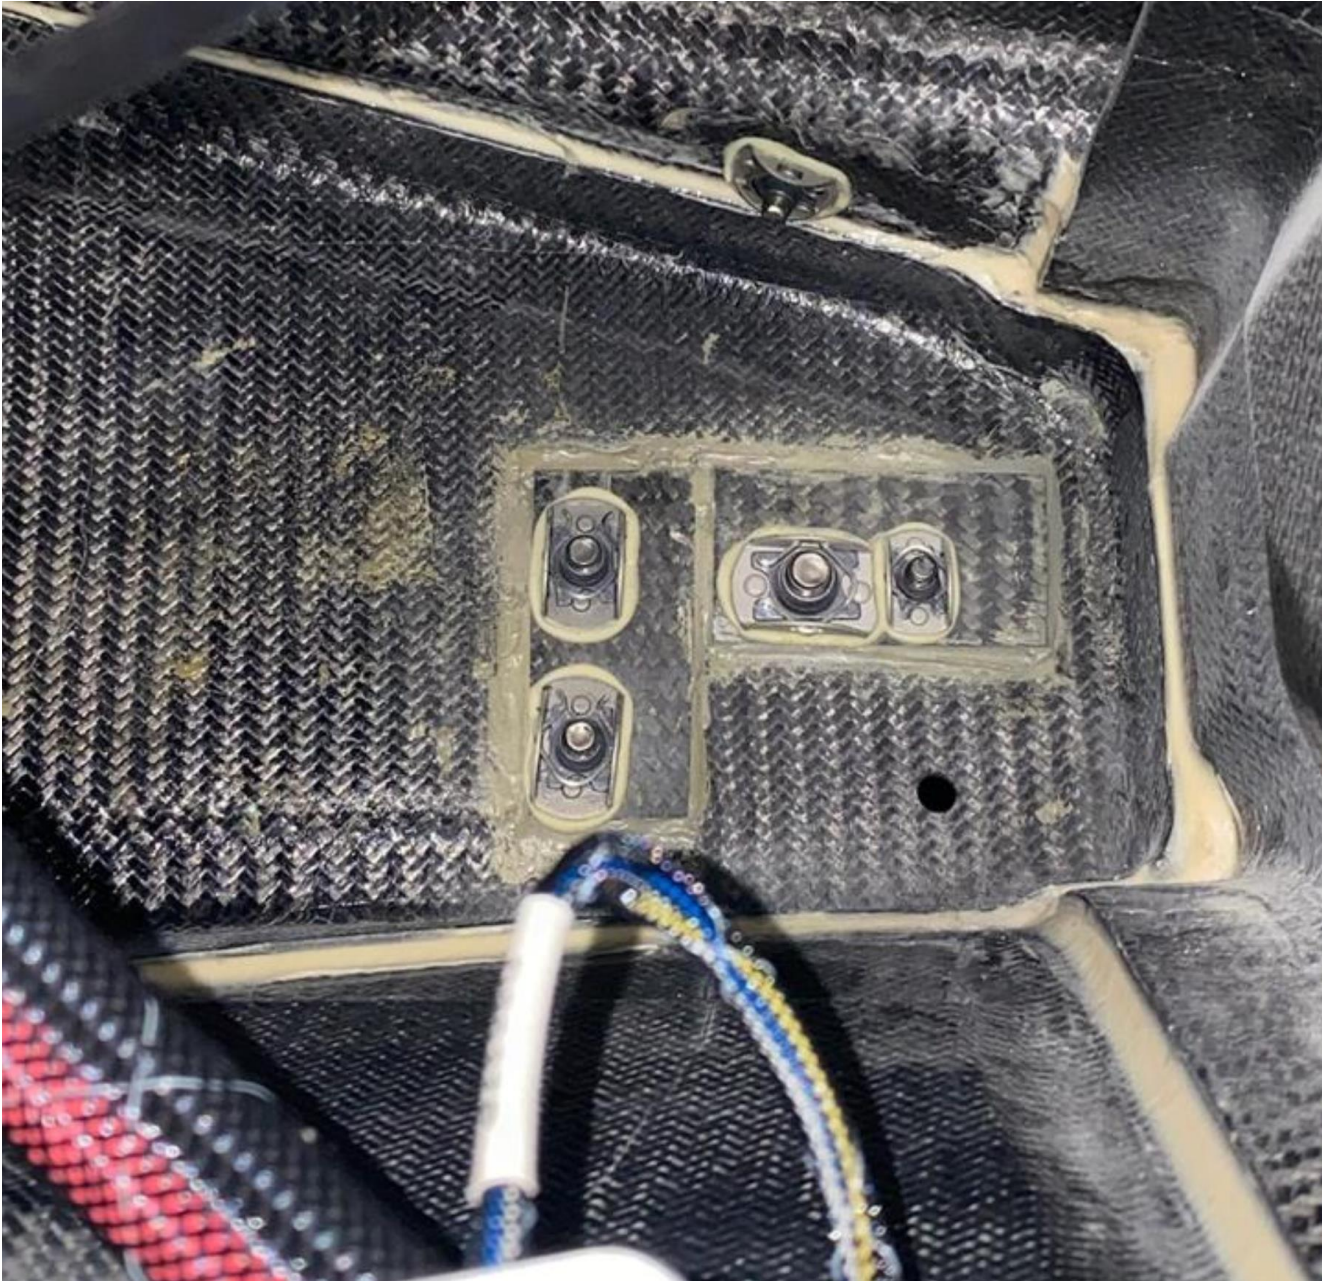
Figure 3: Potentially inadequate repair (measurements must be taken of the repair plates)

- 6) Send all photos of the attachment point area (with measurement photos if appropriate) to ICON Aircraft Engineering at support@iconaircraft.com. ICON will provide further guidance via email once analysis of the photographs is completed. You should expect to receive a response from ICON regarding the need for any additional repairs within one (1) business day upon receipt of the photographs. Do not reassemble the aircraft. If a further repair is required, additional disassembly will be necessary.

- 7) If a further repair is required, ICON will provide repair documentation and coordinate the composite repair.
- 8) If a further repair is not required, reassemble the following components in accordance with the current release of the Aircraft Maintenance Manual, ICA00833.

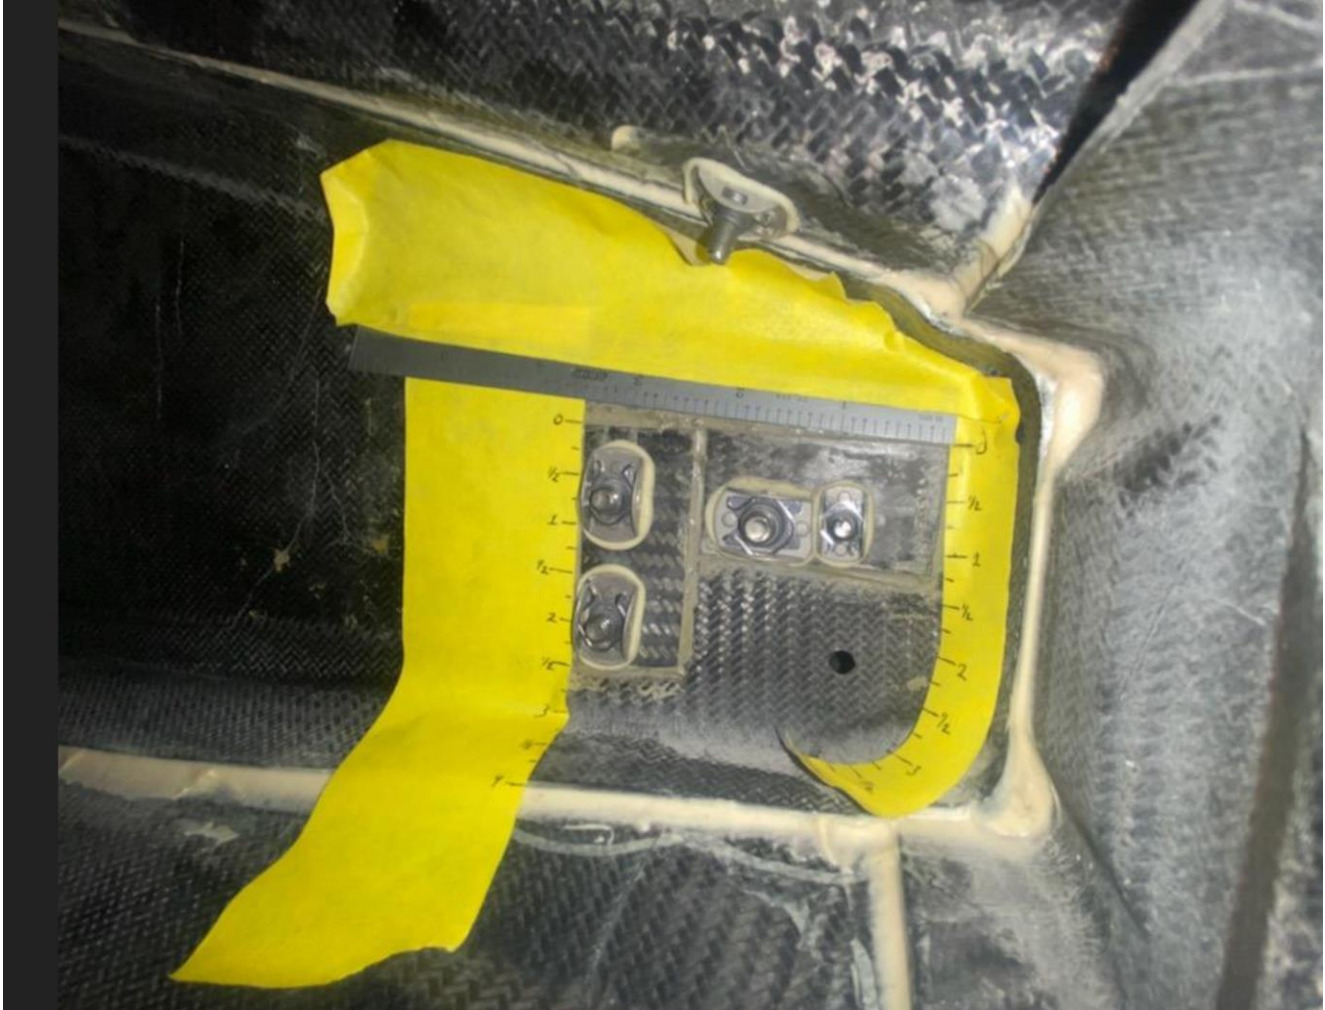
Figure 4: Example of one method to document dimensions of repair plates
