SERVICE LETTER

SL-121619 REV A

DATE ISSUED: 1/13/2020
DATE EFFECTIVE: 1/16/2020
SUPERSEDES NOTICE: N/A
SUBJECT: Optional Improvement - Removal and Replacement of Wing Hang Pins
AIRCRAFT AFFECTED: **MODEL:** A5
S/N: ASN 1, 2, 5, 6, 9, 12, 15, 17, 18, 20, 23-34, 36, 38, 40-43, 45-47, 49, 50, 52-72, 74, 76-97, 99-101, 103-108

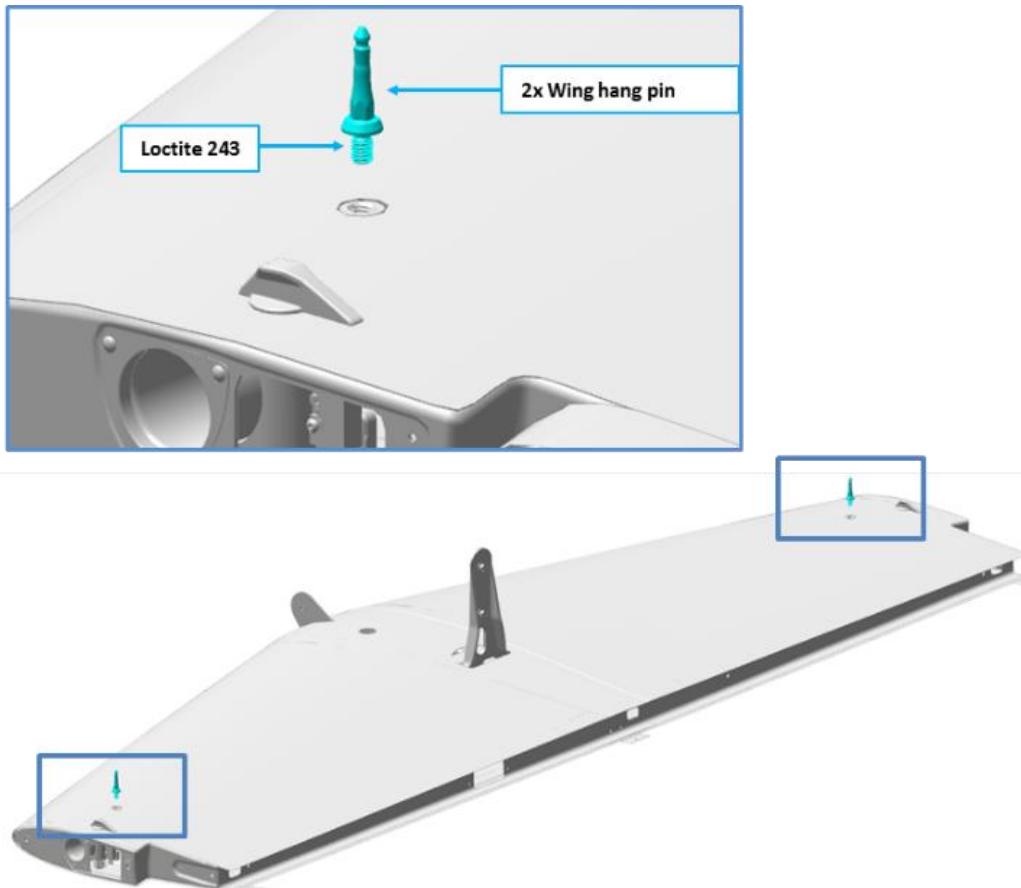
Figure 1: Wing Hang Pin Install

ICON is committed to designing, manufacturing, delivering, and supporting a high-quality Light Sport Aircraft. This Service Letter is to notify owners of an upgraded Wing Hang Pin made from a material that reduces fatigue and increases the life of the pin. This notification includes instructions for replacing the Wing Hang Pins.

2. ____ Apply Loctite 243 onto the threads of the new wing hang pin, Figure 1.
3. ____ Install new wing hang pins (ICA013760) into the Horizontal Tail.

4. ____ Torque wing hang pin to **150 inch-lb.**
